Maximizing UHF Radio Range for GNSS Base/Rover Pairs

Date: 26 November 2019

By: Mark Silver, <u>ms@igage.com</u>, +1-801-412-0011 x16

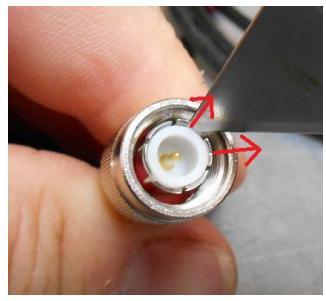
The antenna connector can become intermittent and not make a solid connection. If antenna is overtightened, then the connection points shown above can become 'sprung' and won't make good contact unless the antenna is screwed in even tighter.

Bending out the ground contacts on the antenna connector.

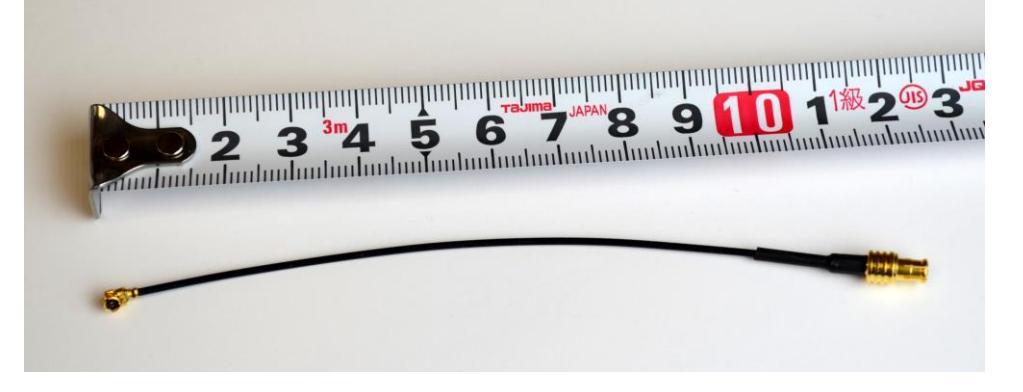
Devices occasionally experience failures in the internal coaxial cable connection between the UHF TNC connector on the bottom of the receiver and the Satel radio SMA connector.

This 12 cm long cable connects the TNC UHF Antenna Connector to the SMA connector on the Satel radio:

We believe that this connector failure issue is exasperated by repeated vibrations on the cable termination to the SMA connector, perhaps from extended transport on vibrating platforms.

If you find that the connection is open (infinite resistance or resistance over 4 ohms) call us and we will arrange to fix your receiver. The process does not take long however it is not a procedure that you should attempt, we replace the wire and provide additional strain relief for the cable where it connects to the Satel radio module.

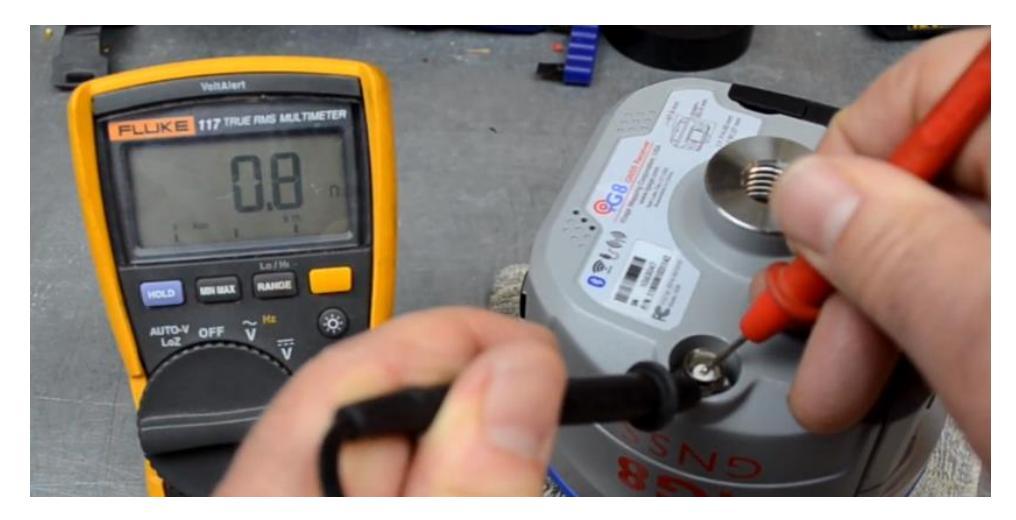
You can easily verify that the cable is working by measuring the resistance between the outside and center of the TNC connector:

The resistance should be between 0.5 and 4.0 ohms. This [video] shows how to make the measurement and read the voltmeter.
