Maximizing UHF Radio Range for GNSS Base/Rover Pairs

Date: 26 November 2019

By: Mark Silver, <u>ms@igage.com</u>, +1-801-412-0011 x16

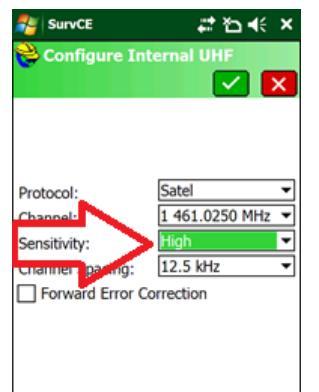
The receive sensitivity is set on the Rover is under "Equip: GPS Rover: RTK (tab): Internal UHF Radio Settings":

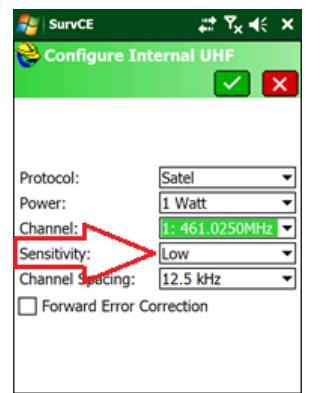
This is an FCC requirement and cannot be disabled. However, the FCC does not specify how carefully we need to listen for adjacent traffic. So we set the receive sensitivity on the base to 'Low'.

The setting for the base output power is under "Equip: GPS Base: RTK (tab): Internal UHF Radio Settings":
