ADL Vantage 35 Repeater Notes

(Version 5.02 Firmware and higher)

Best Practices for ADL Repeater operation.

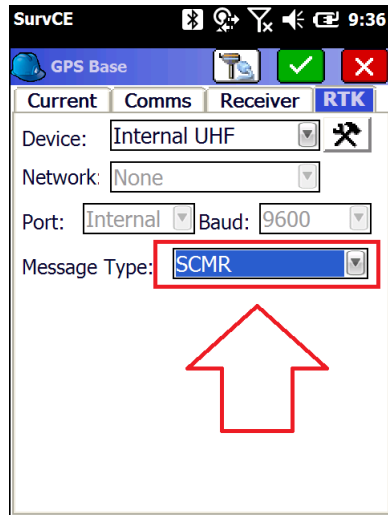
When configuring a Base in SurvCE for use with a repeater, set the correction protocol to 'sCMR' on the RTK tab of the GPS Base configuration:

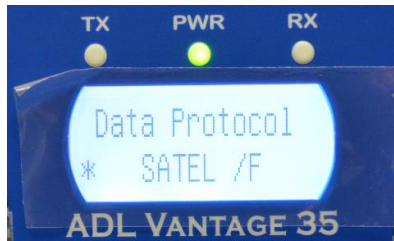
With version 5 radio firmware when you have selected the correct 'Data Protocol', the radio display will show 'SATEL /F':

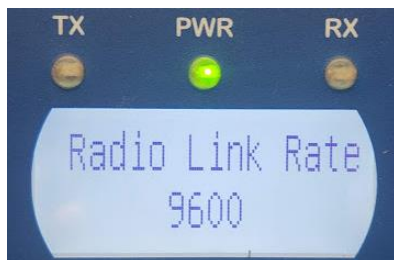
And the 'Radio Link Rate' will be 9600:

This is important, if the 'Radio Link Rate' is 19,200 you have set the bandwidth to 25 KHz and it will not work.

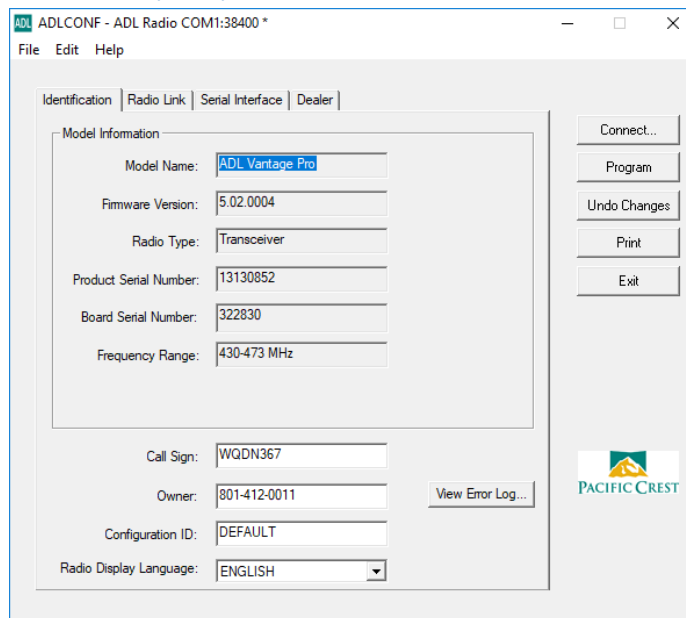
Identification (tab)

We put the owner's phone number in the Owner box. You must have a FCC license to broadcast, and the FCC call sign must be transmitted every 10 minutes. So put your call sign in the appropriate box.

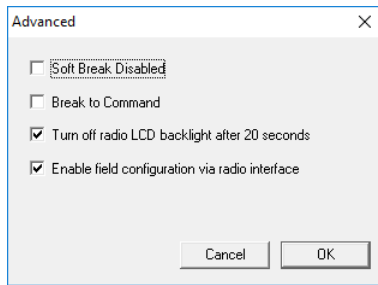
Clicking the Advanced button:

Leave everything unchanged.
