September 2023 iG9 Firmware Update

29 September 2023

In addition to the new, updated OEM, Radio and Mainboard firmware is available for the iG9 and iG9a released with version 2.2.4.x in March 2023; this release fixes a single (perhaps arcane) radio frequency programming issue in the iG9 and iG9a.

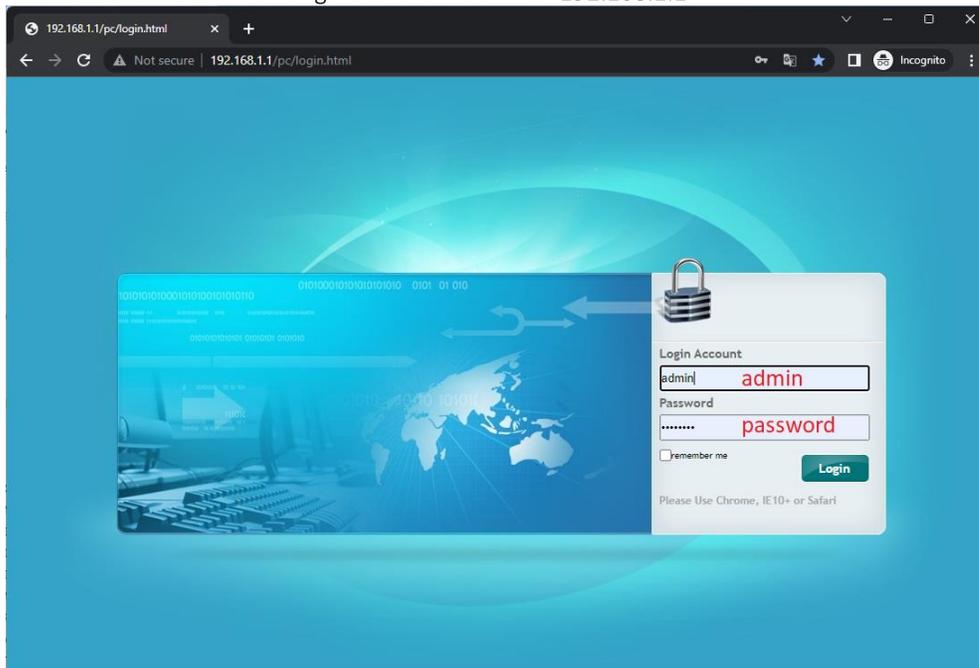
Open a browser window and navigate to the IP address: **192.168.1.1**:

The **Login Account Name** is **admin** and the **Password** is **password**. Click on **Login**.

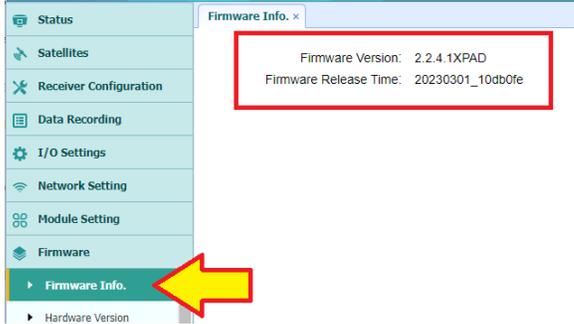
On the left panel, click on **Firmware**, then **Firmware Info**. The current firmware version will be displayed:

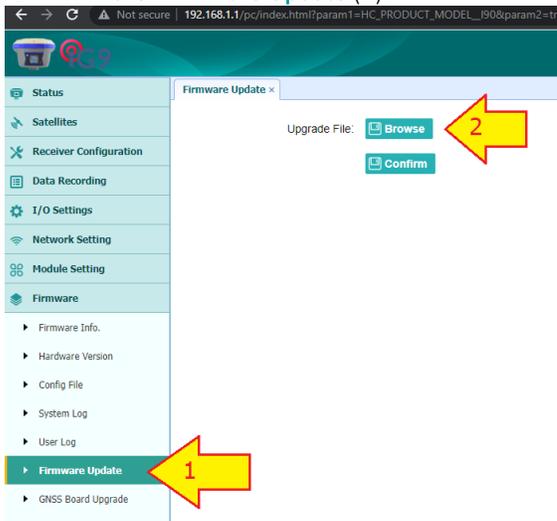
Click on **Firmware: Firmware Update** (1):

Then click on **Browse** (2) select the file the correct mainboard update file, finally click on **Confirm**.

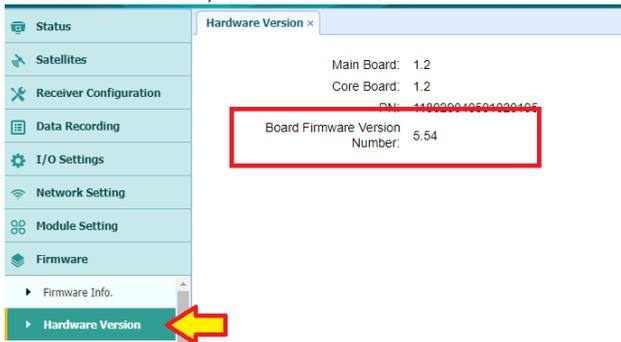
From the web interface, click on **Firmware: Hardware Version**:

If the Board Firmware Version Number: is less than 5.54 then continue and update the OEM firmware. (The current version is 5.54/6.14MaxPro, which will display as 5.54 on the web interface.)

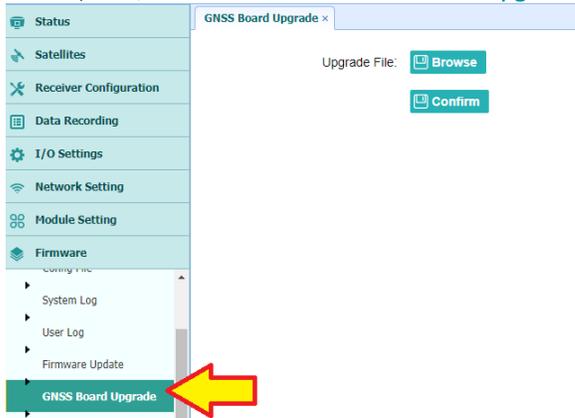
On the left panel, click on **Firmware: GNSS Board Upgrade**

Then click on **Browse** and select the previously downloaded file:

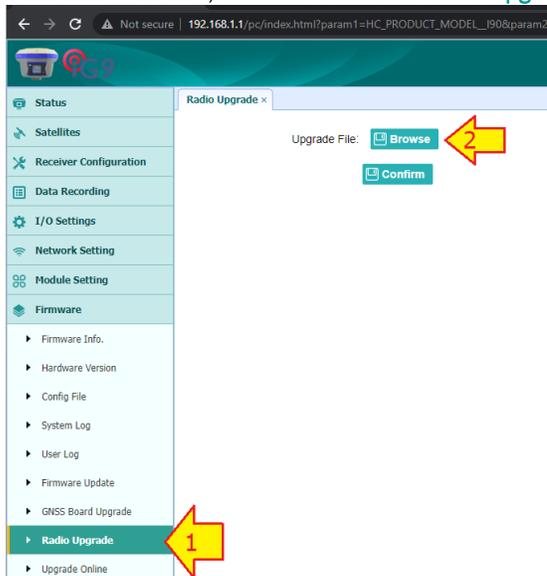
From the web interface, click on **Firmware: Radio Upgrade:**

Then click on **Browse** and select the previously downloaded file:

then click on **Confirm**. **The update will take about 4 minutes** and the receiver will reboot twice during the update.

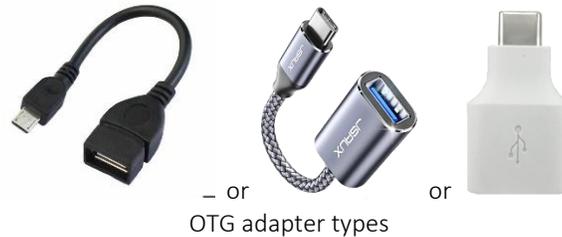
Find an empty thumbdrive and the OTG cable provided with your iG9/iG9a:

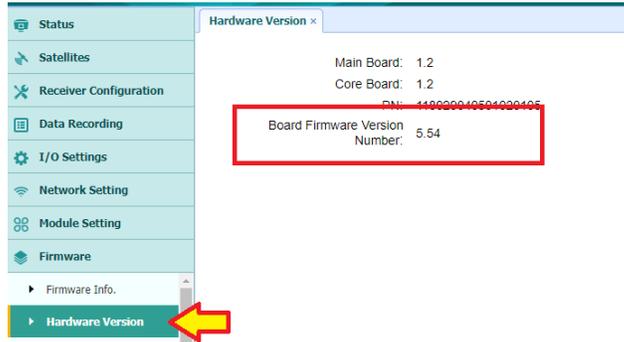
The following list of OEM engine improvements summarizes the enhancements by OEM version. You can determine the current OEM firmware (shown on the Hardware Version) on your device using the web interface where the 5.xx version is shown:
